Three Creeks Parkway Restoration Project Adaptive Management and Monitoring Plan

**A Project With American Rivers and Contra Costa County Flood Control and
Water Conservation District**

November 2019

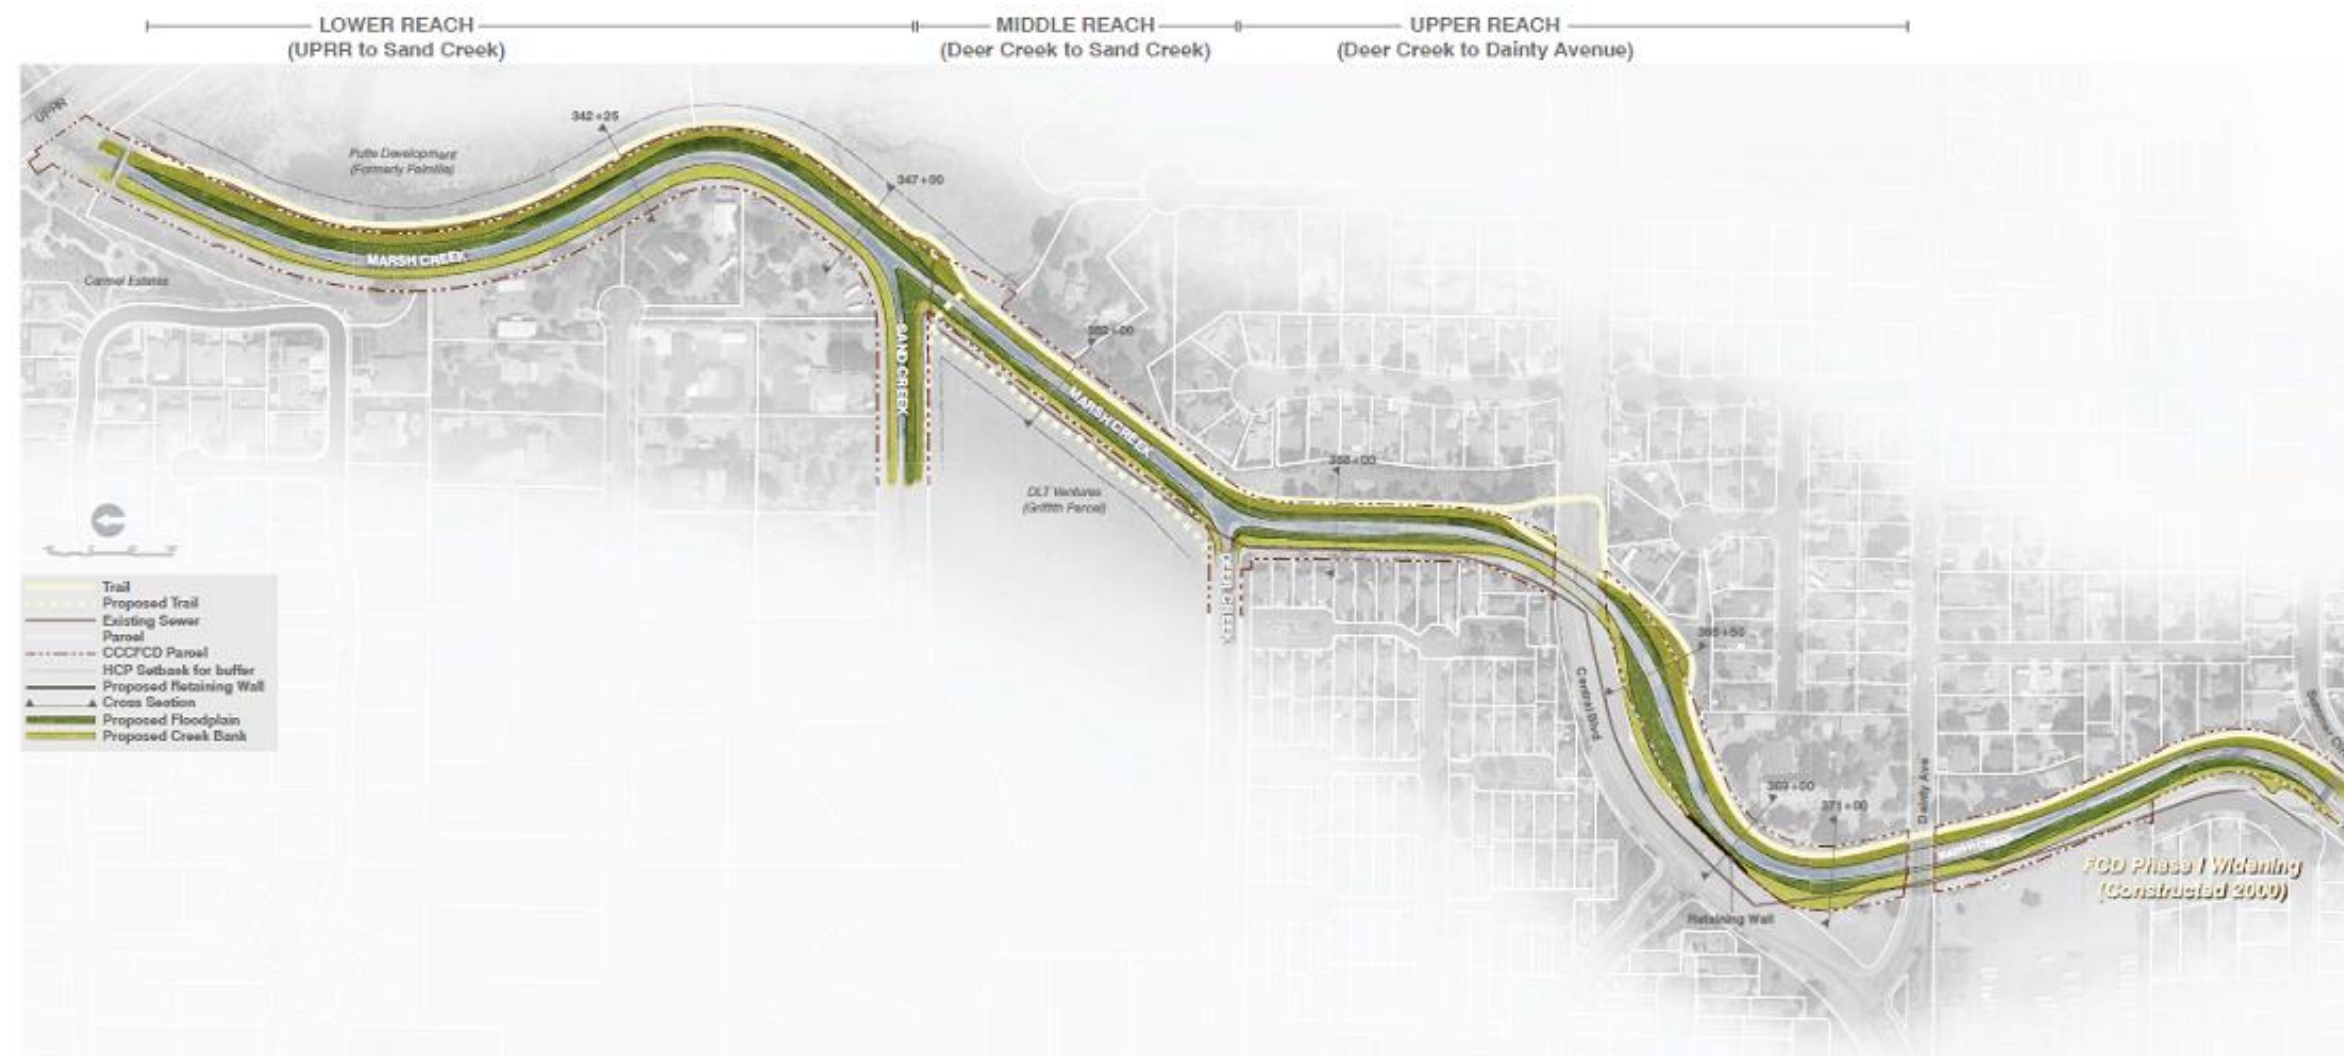
Figure 2. Project Site Plan

The upper/southern limit of the project is just north of Dainty Avenue Bridge while the lower/northern limit is the pedestrian bridge across Marsh Creek about 175 feet south of the Union Pacific Railroad (UPRR) tracks. Marsh Creek trail, a regional trail owned by EBRPD is located on the east bank of Marsh Creek within the project area. As shown in **Figure 2**, the project is divided into three reaches.

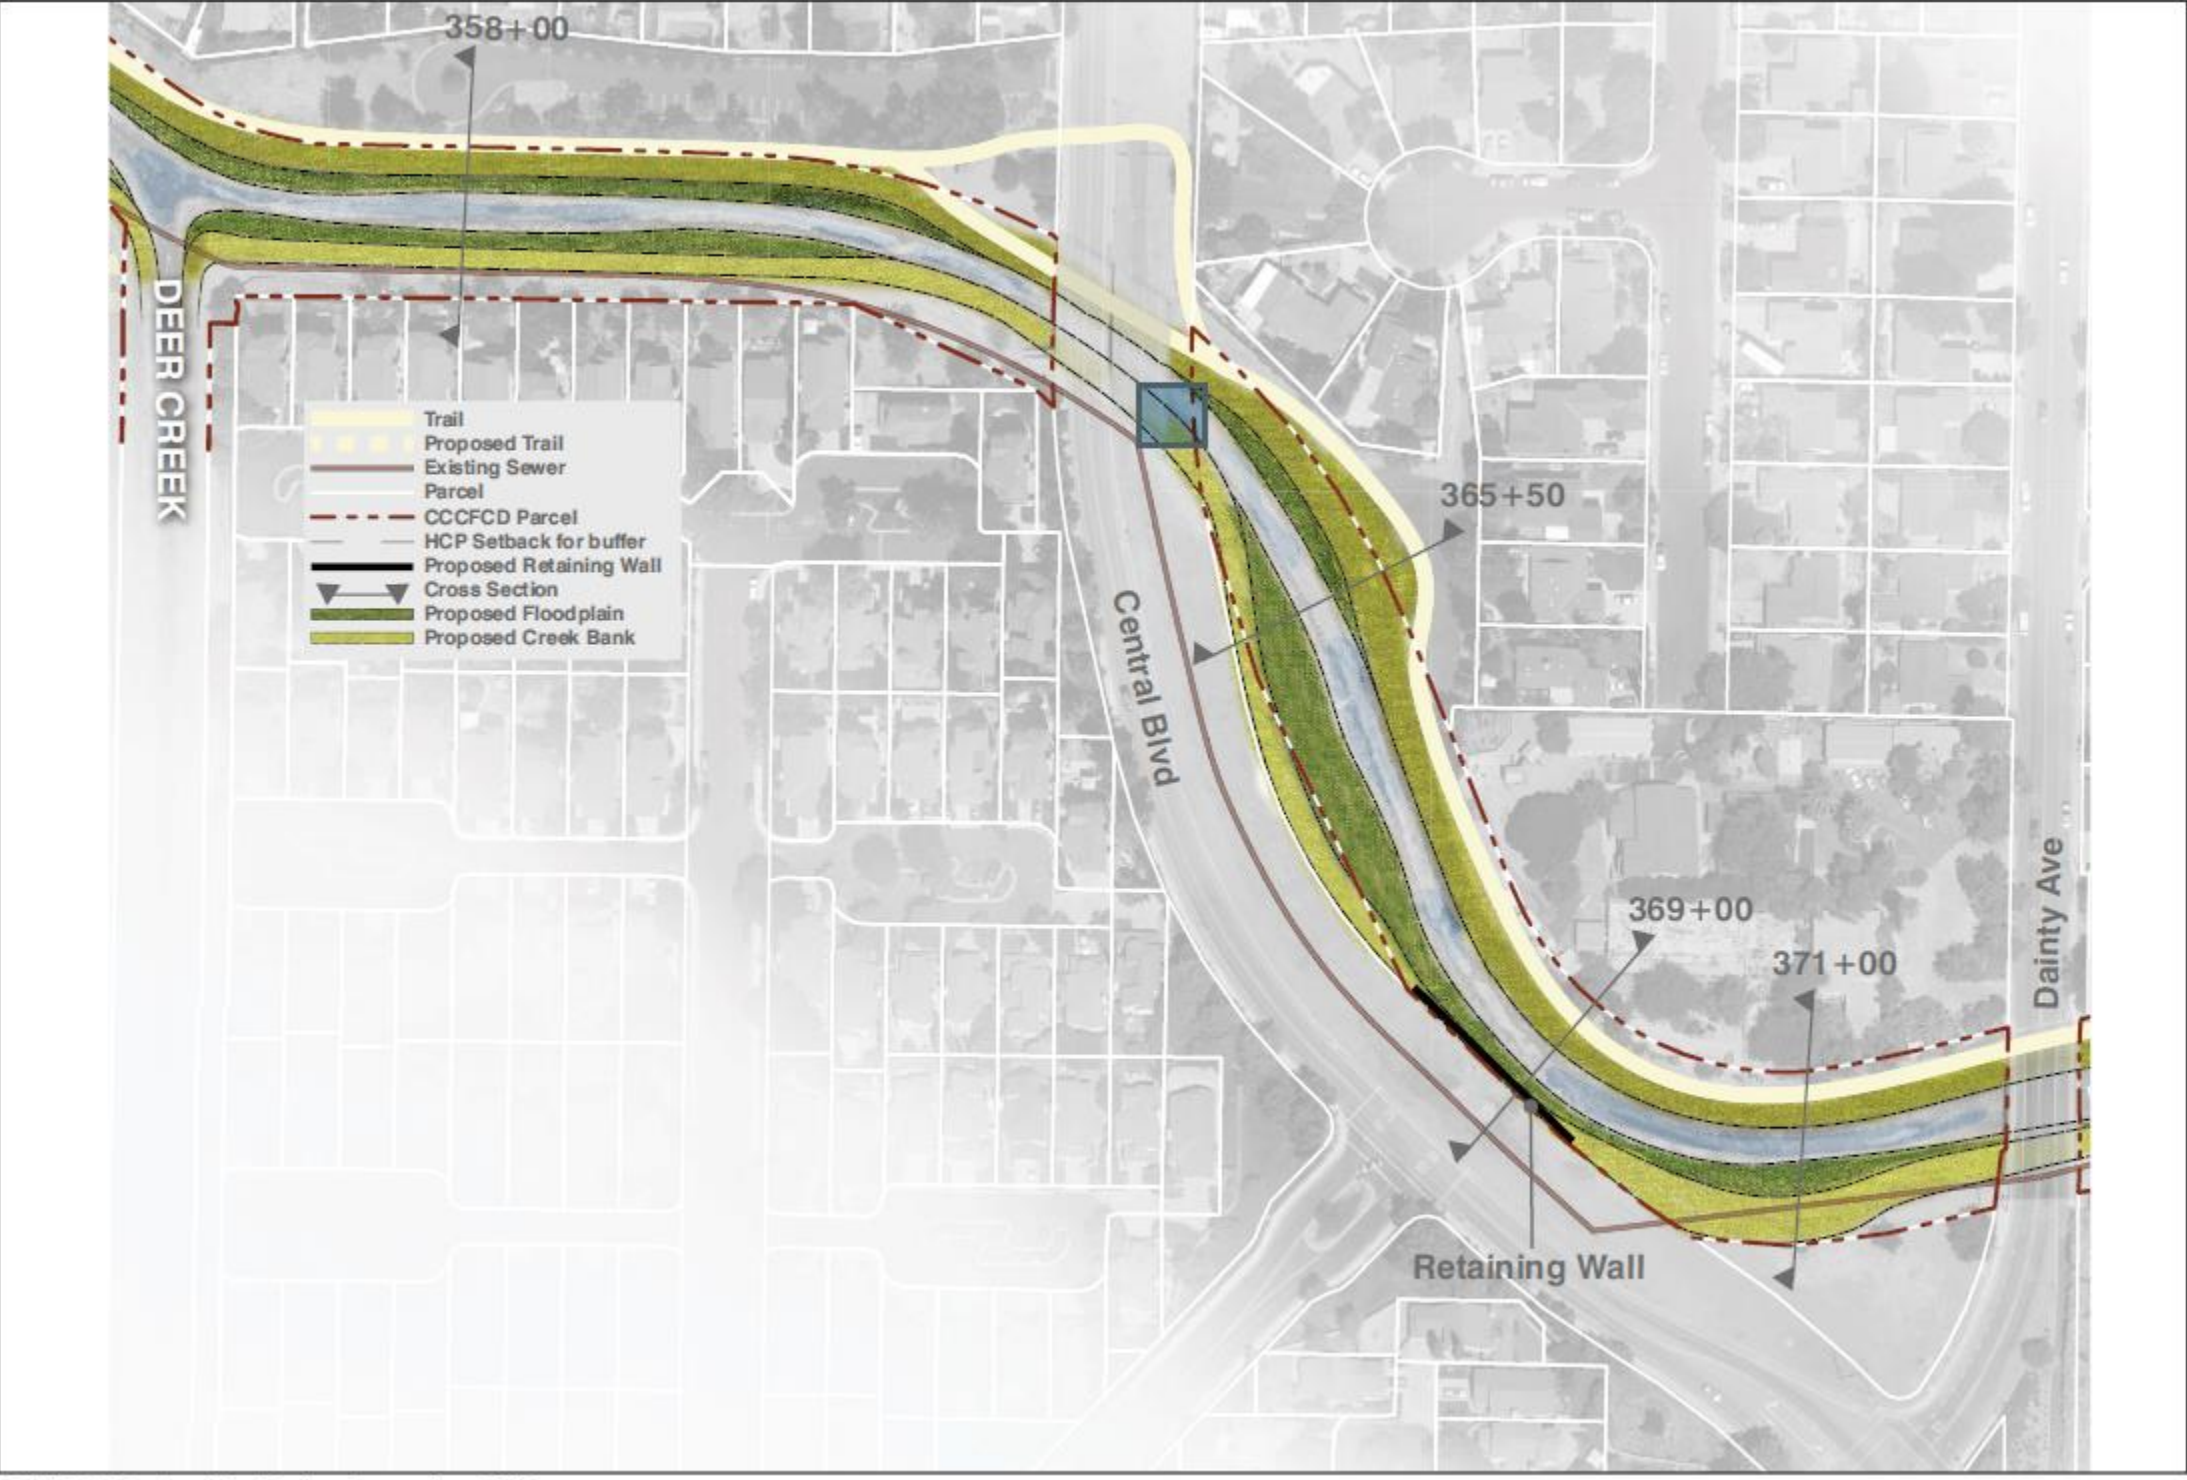
SOURCE: Restoration Design Group, Inc. 2016
Figure 3. Upper Reach Improvements

As noted earlier, the Upper Reach is approximately 1,600 feet of the channel between just north of Dainty Avenue bridge and the Deer Creek confluence. The reach is constrained by development on both sides and channel widening in this section will include excavation of both banks to construct a number of floodplain benches on both sides of the creek of varying widths with slopes ranging from 2:1 to 3:1 (**Figure 3**). The benches will be located above the ordinary high water mark (OHWM). The construction of the floodplain benches would satisfy the District's freeboard requirements for an earthen channel. **Figure 4** presents existing and modified creek cross-sections for this reach. Once the benches are constructed, permanent slope protection such as erosion control matting or other biotechnical methods would be installed on all benches and slopes for slope stabilization and to prevent long-term effects of erosion. The selected erosion control material would provide soil stabilization and promote vegetation growth.

Widening the channel cross-section is expected to decrease velocities and erosion potential. However, detailed hydraulic modeling that will be completed to inform the final design may indicate that some bank armoring is necessary where the expanded channel will taper down to the existing channel at the downstream project boundary. In one location along the Upper Reach, the project will require a retaining wall along approximately 250 feet on the left (west) bank due to the presence of Central Boulevard in Brentwood that will extend approximately 5 feet above ground. The retaining wall will rise from the back of the floodplain and would not touch the low flow channel. The project also includes replacement and repair of grouted rock at the Deer Creek confluence.

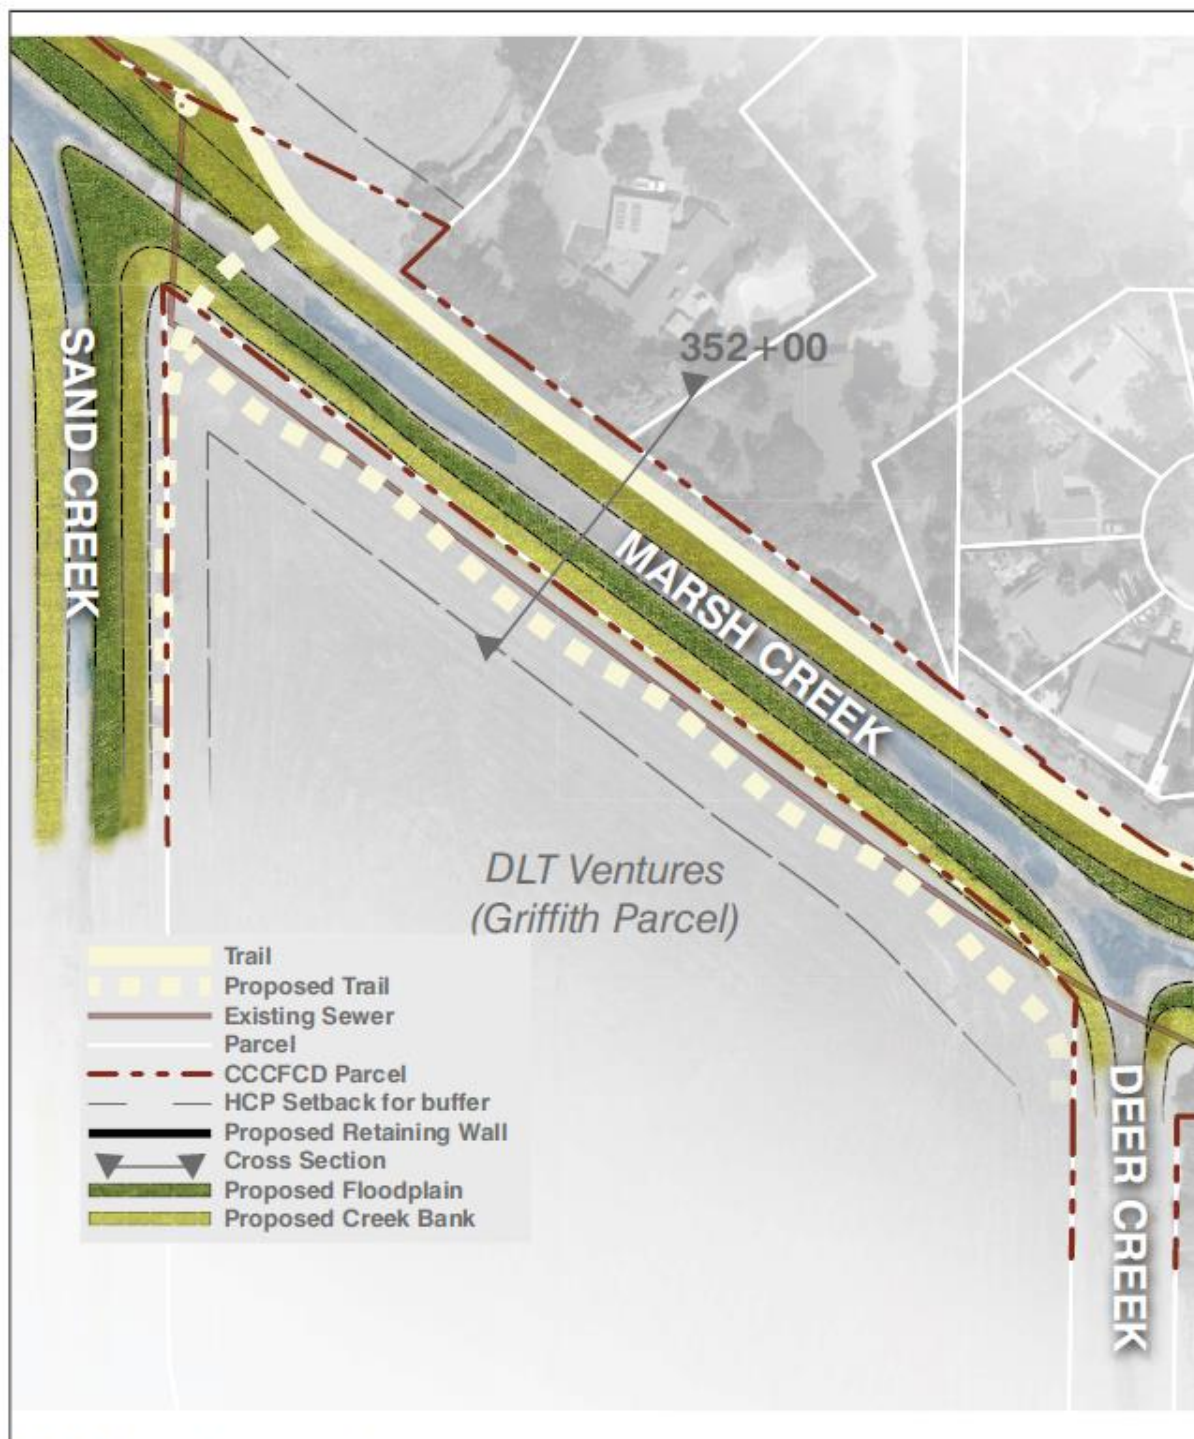
Figure 5. Middle Reach Improvements

The Middle Reach, which is about 800 feet in length, will be widened along the west bank as part of the proposed project. As the Middle Reach is also constrained, channel widening will involve excavation of both banks to construct a number of floodplain benches of varying widths as shown in **Figure 5**, with slopes ranging from 2:1 to 3:1. The benches will be located above the OHWM. The construction of the floodplain benches will satisfy the District's freeboard requirements for an earthen channel. **Figure 6** presents existing and modified creek cross-sections for this reach.
