FLOOD HAZARD MITIGATION PLAN FOR THE SACRAMENTO-SAN JOAQUIN DELTA

Delta Flood Emergency Management Plan

Water Project Export Disruptions
for Multiple-Island Breach Scenarios
using the Delta Emergency
Response Tool

Insights into the Problems, Progress, and Potential Solutions for Sacramento River Basin Native Anadromous Fish Restoration

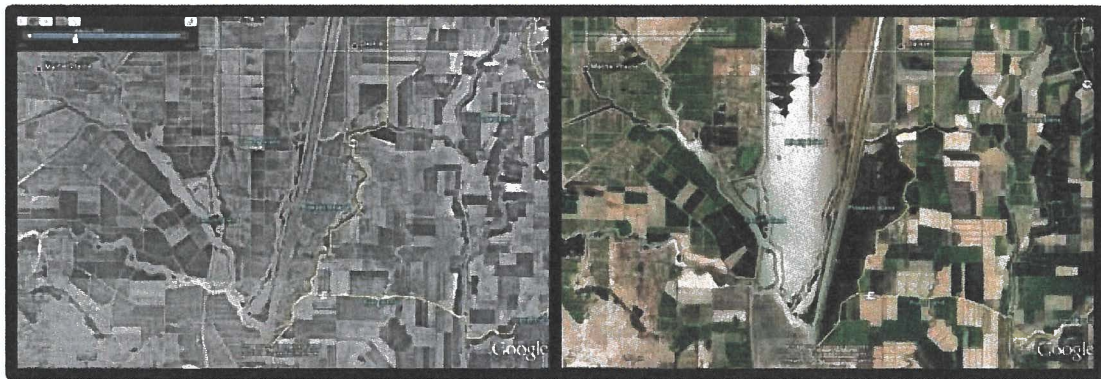
Figure 72. Liberty Island in the north Delta before and after flooding.

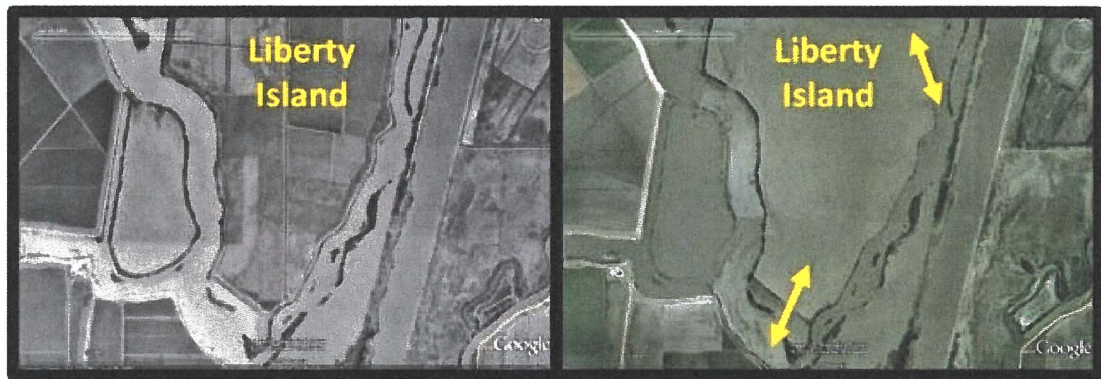
Figure 73. Liberty Island in the north Delta before and after flooding showing locations of narrow breaches in the levee.

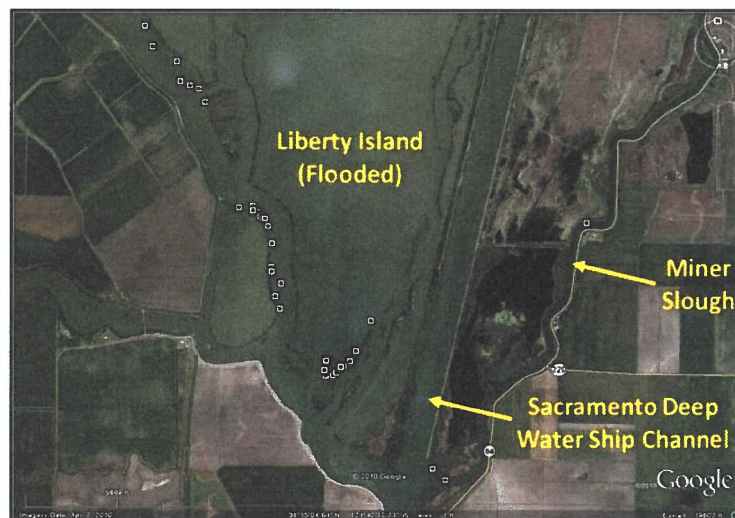
Figure 74. Locations (squares) where predatory striped bass were acoustic-tagged with transmitters during the winter of 2008 – 2009 in the north Delta near Liberty Island (D. Vogel, unpublished data).

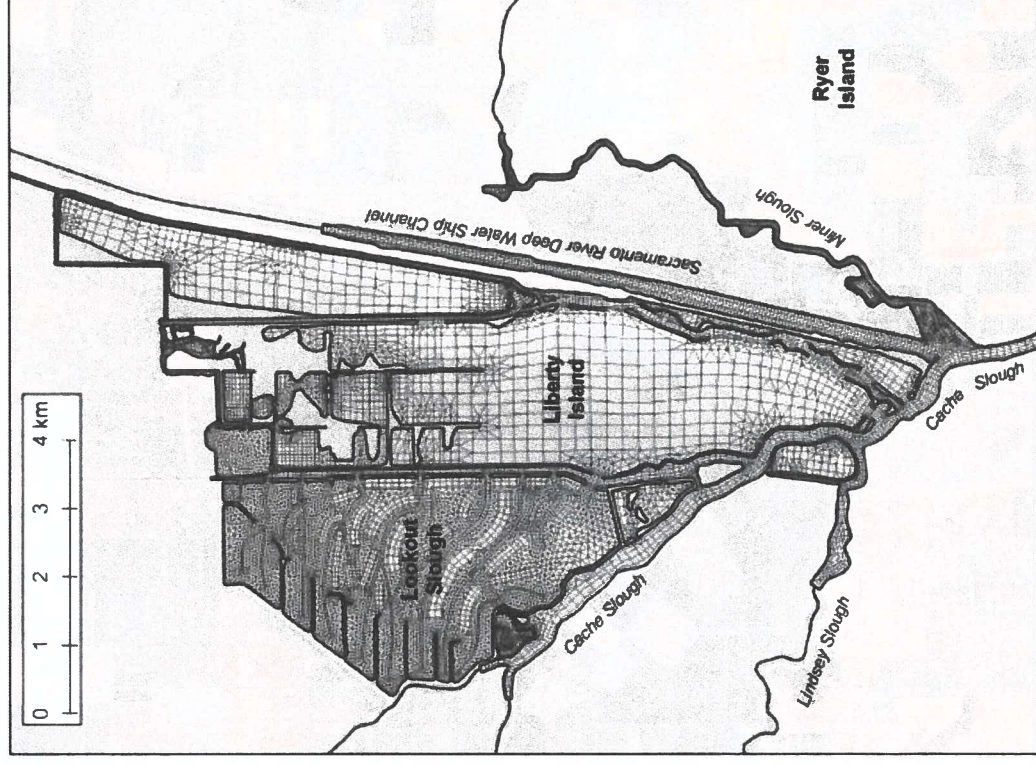
Figure 3 Detail view of the model configuration with Lookout Slough restoration.
