## **GEOTECHNICAL INVESTIGATION**

### **MOKELUMNE RIVER WATERSIDE HABITAT ENHANCEMENT AND LEVEE REPAIR NEW HOPE TRACT, CALIFORNIA**

Project No. 921.01  
November 25, 2020

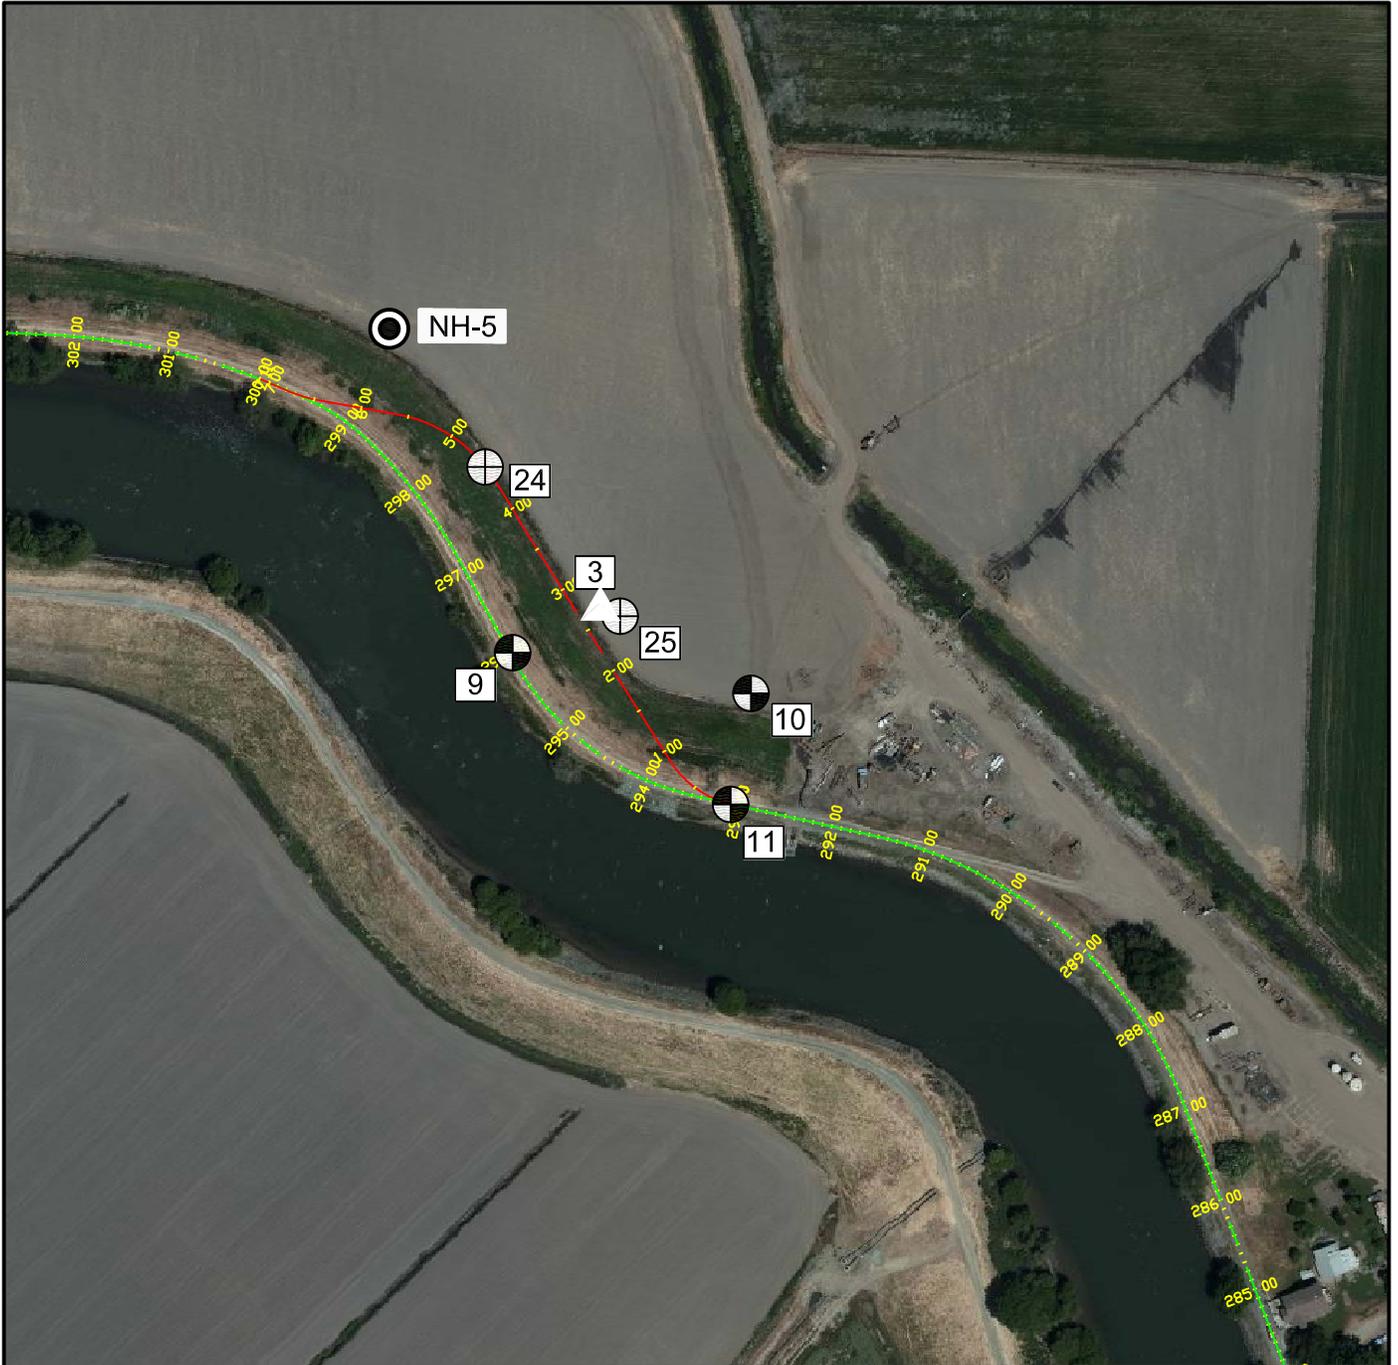
Plate No. 4

Approximate Location of Boring

We explored subsurface conditions by advancing Cone Penetration Tests (CPTs), performing borings either along the crest of the existing levee alignment or the landside levee toe, and performing hand augers along the new levee alignment. The approximate CPT, boring, and hand auger locations are shown on the individual area Site Plans, Plates 3 through 6.

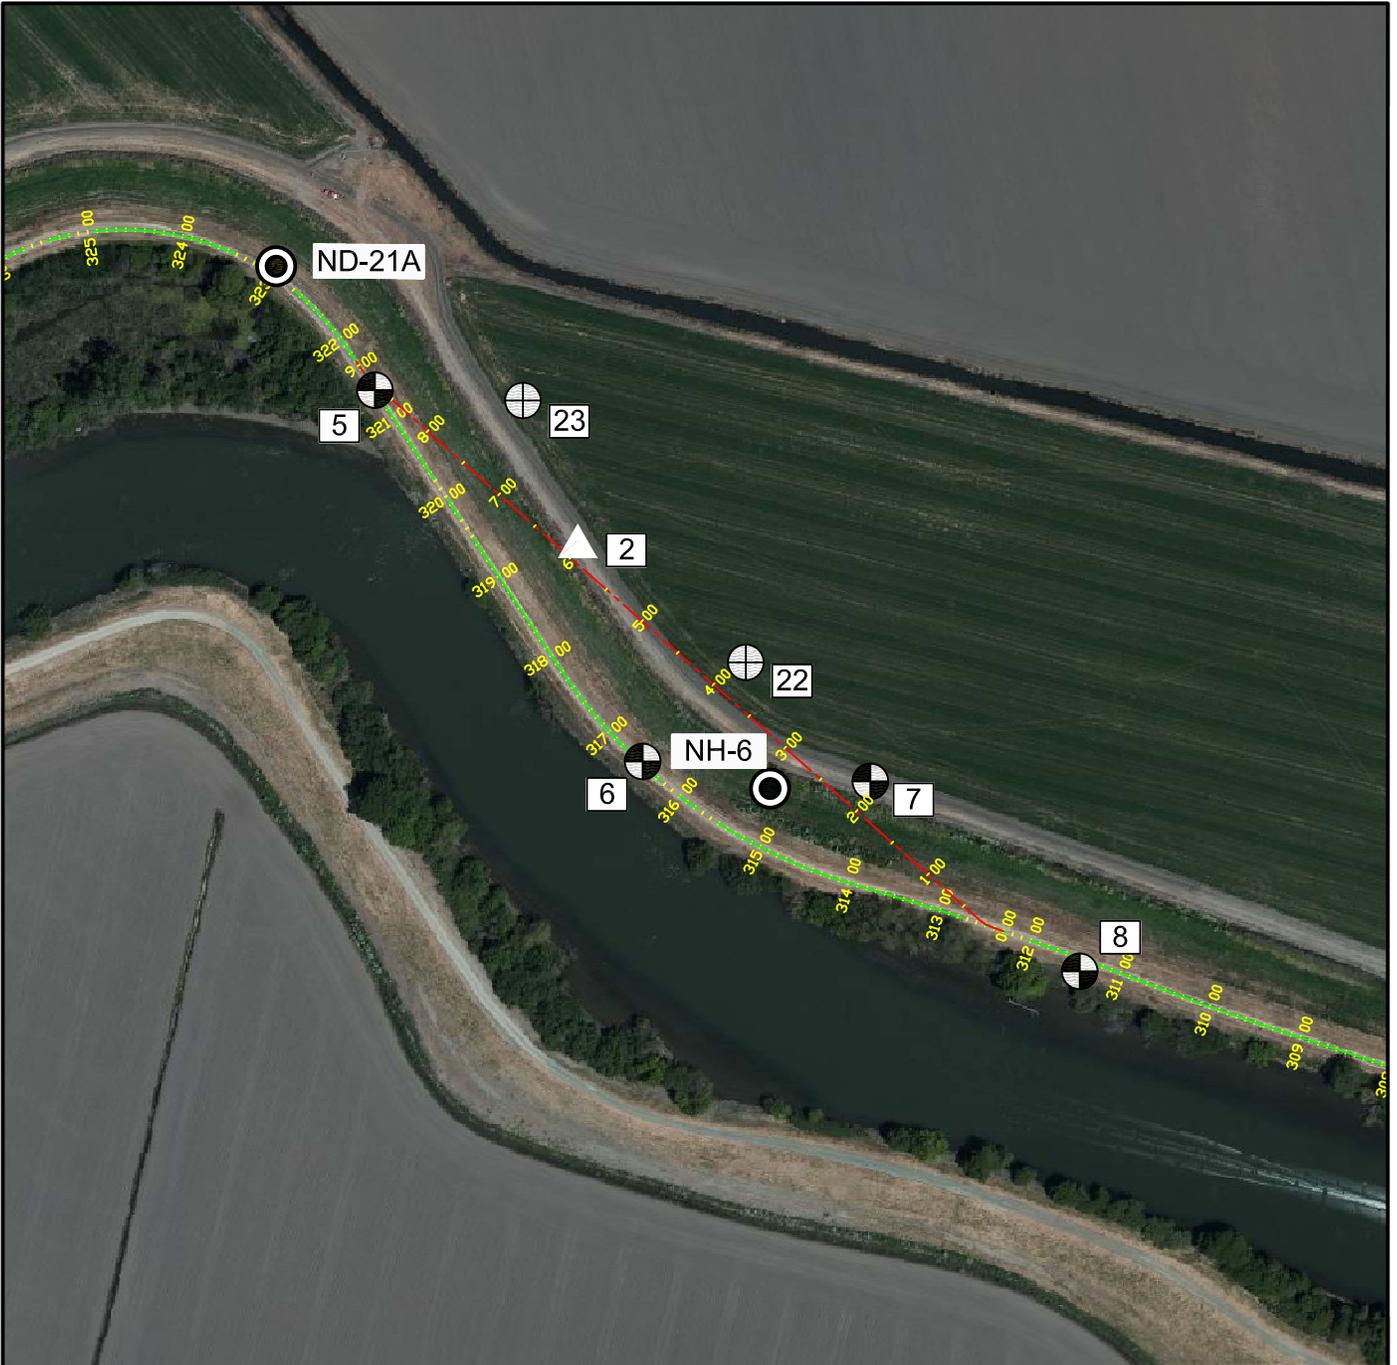
Approximate Location of Boring

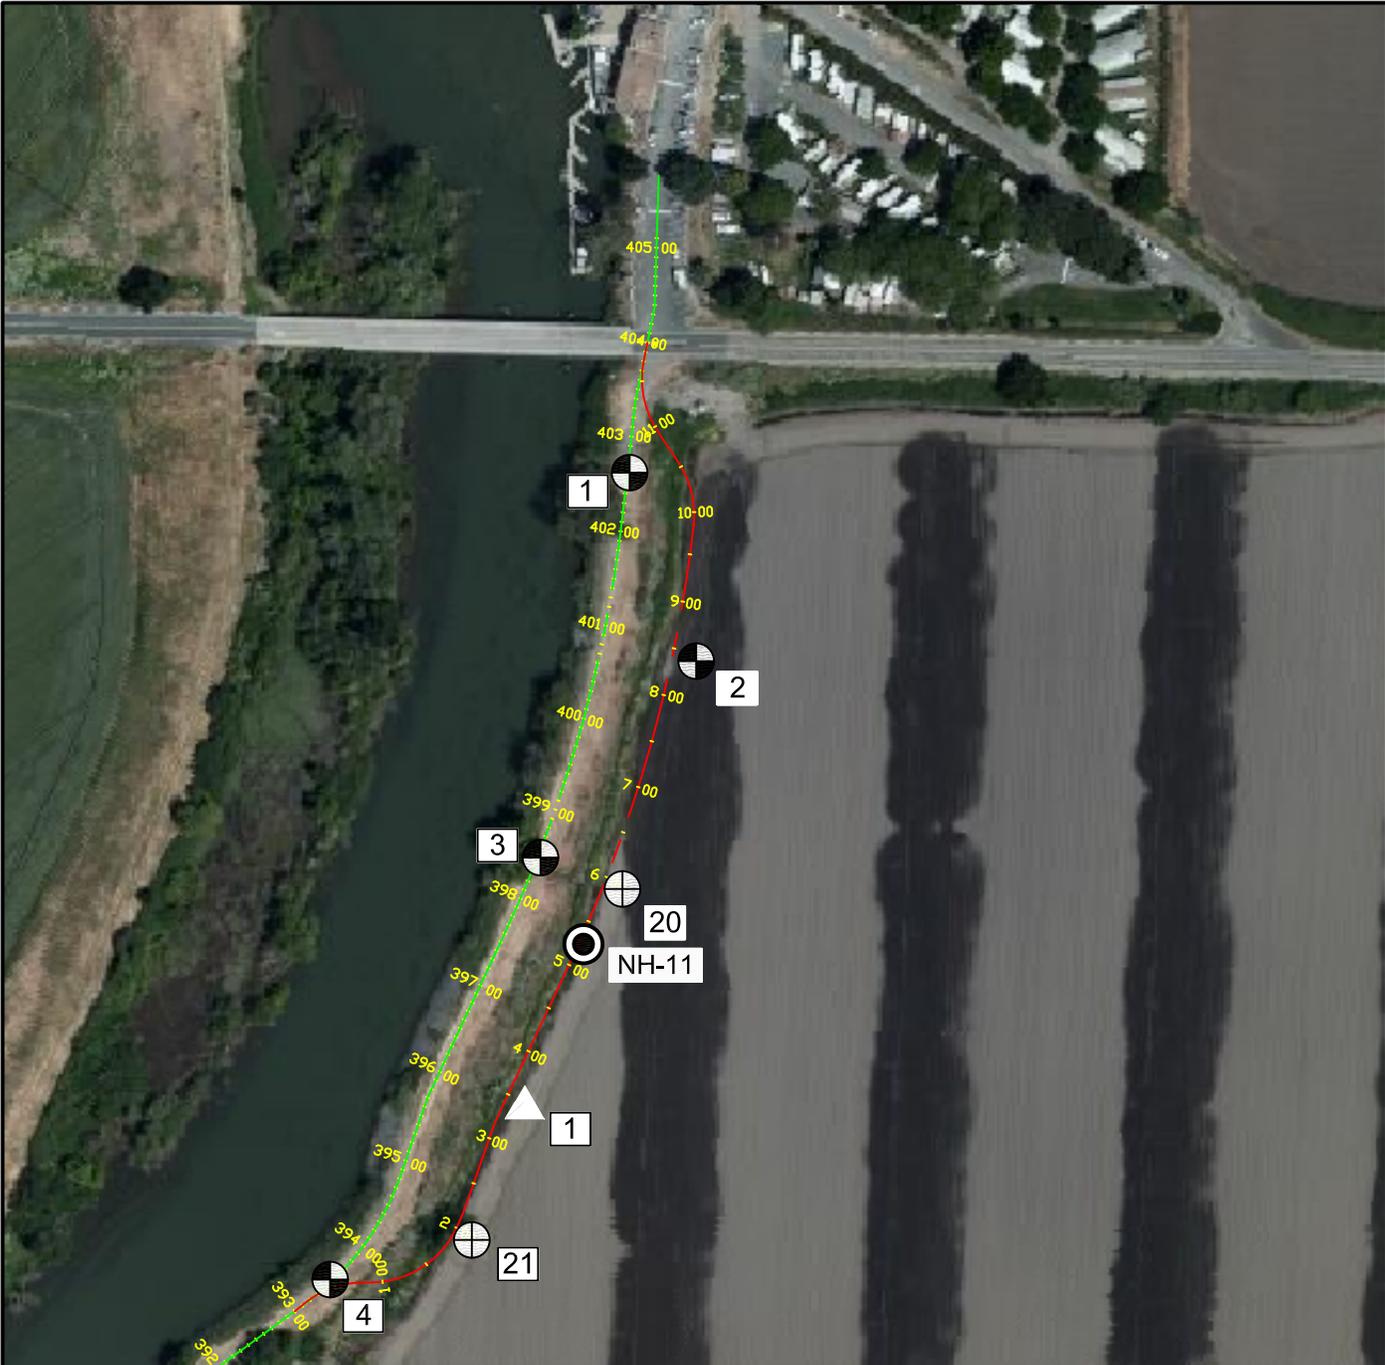
**Site Plan - Area 3**

Approximate Location of Boring

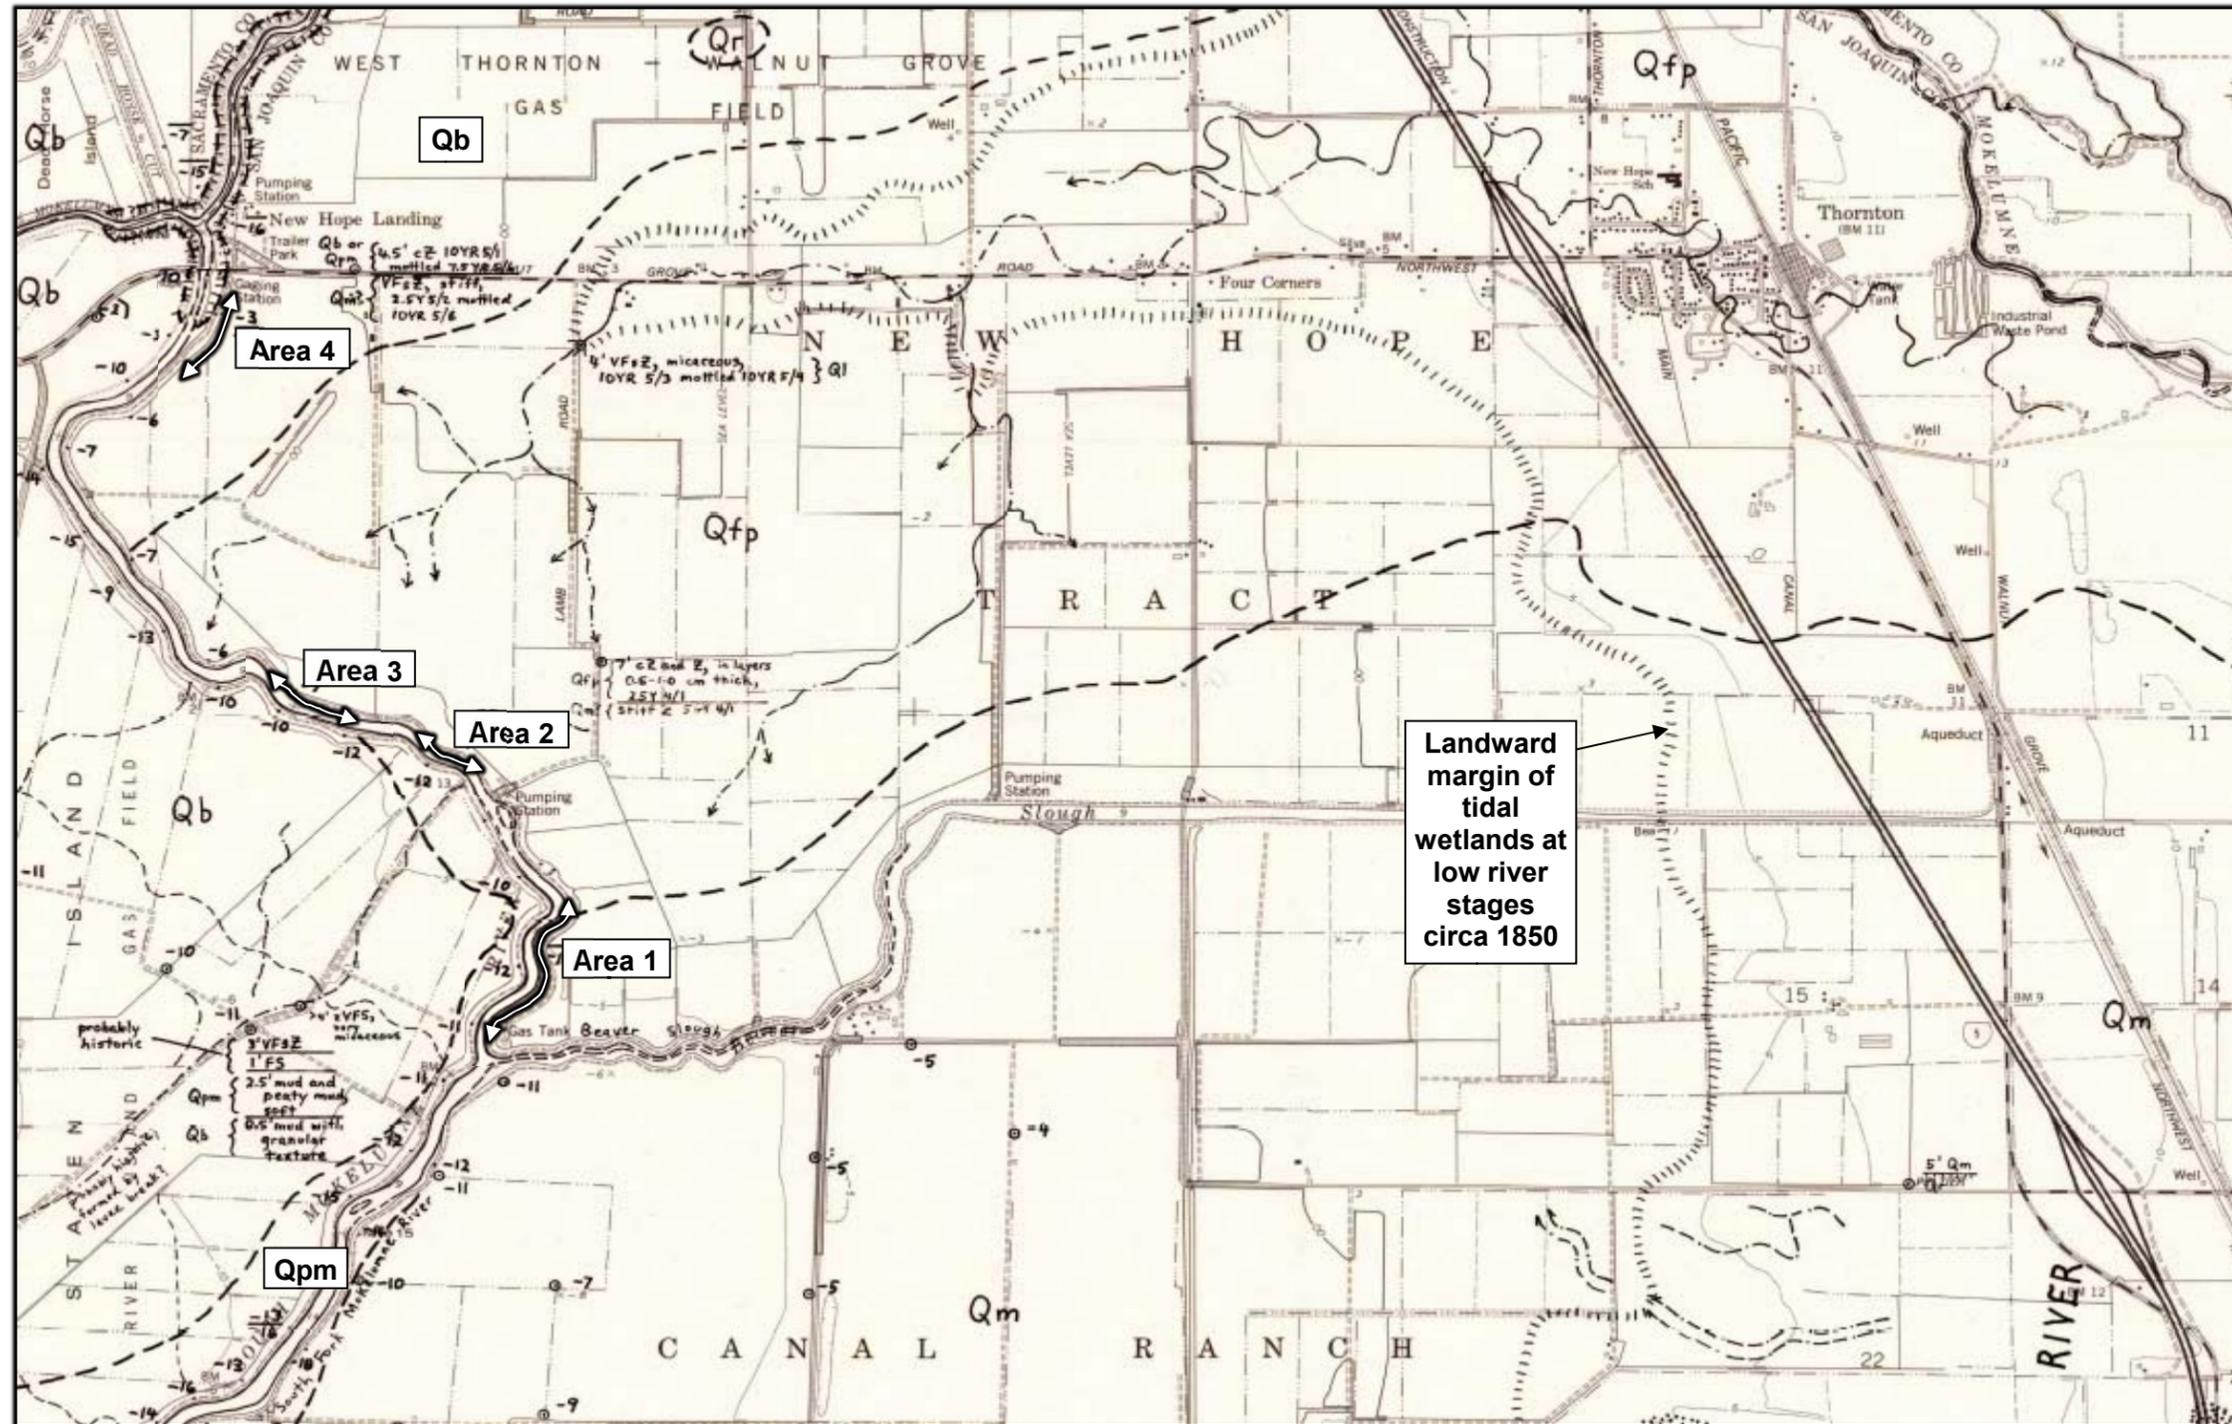
Mokelumne River Waterside Habitat Enhancement and Levee Repair New Hope Tract, California		<b>Geology Map</b>
<b>Hultgren - Tillis Engineers</b>	Project No. 921.01	Plate No. 7

- Qb:** Flood-basin deposits (Holocene)
- Qpm:** Peat and mud of tidal wetlands and waterways (Holocene)
- Qfp:** Alluvial-floodplain deposits, undivided
- Qm:** Modesto Formation (Pleistocene)

- Elevations at base of soft deposits
- 10:** Basal deposits peat or peaty mud
- 14:** Basal deposits mud
- (-1):** Soft deposits missing; firm or stiff deposits at ground surface at indicated elevation

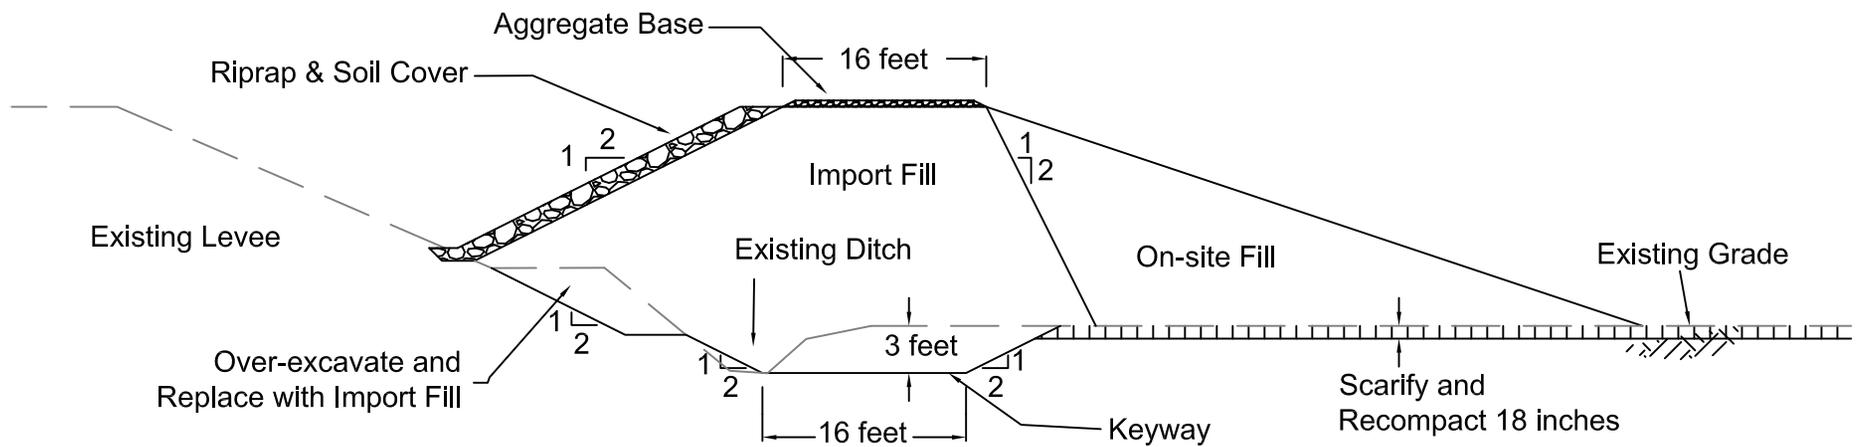
Plate No. 8

1. Levee crest elevation includes a 6-inch overbuild to allow for settlement.
2. Import Fill should meet the requirements presented in our report.
3. Aggregate base should meet Caltrans Class II specifications.
4. Keyway should begin at top of ditch.
5. Staging details are presented on Plates 10 and 11.
6. Over-excavate landside berms within footprint of proposed levee and replace with import fill. Back-cut into existing levee should be no steeper than 2H:1V.

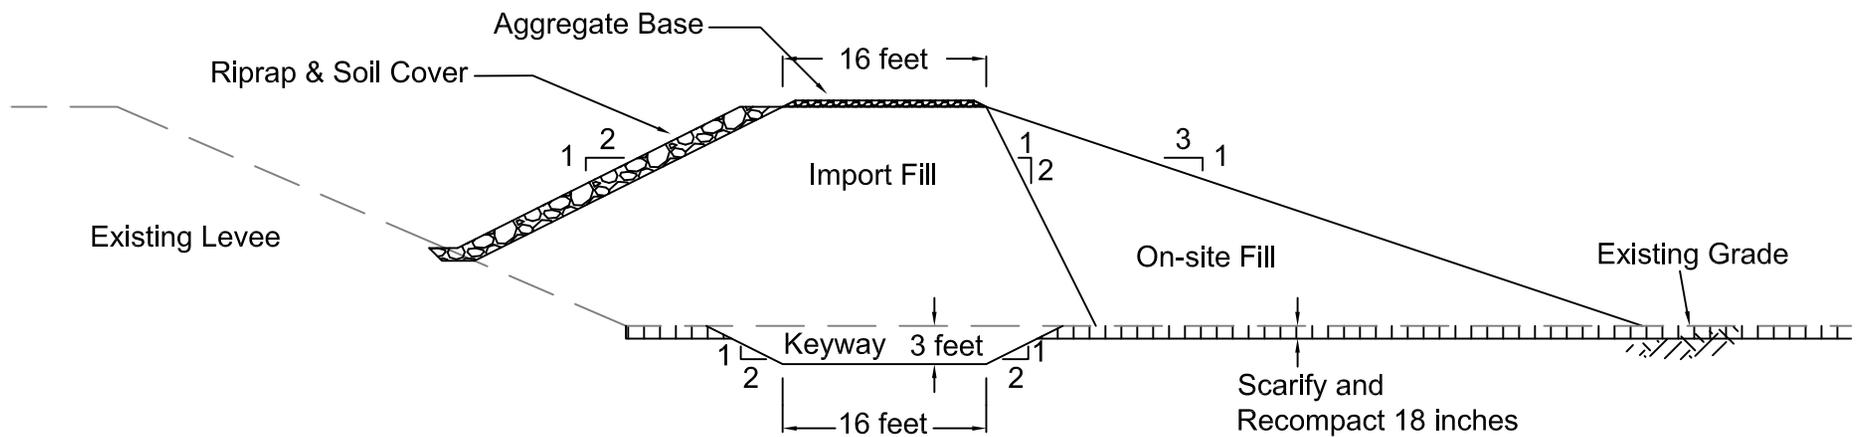
Plate No. 9

1. Levee crest elevation includes a 6-inch overbuild to allow for settlement.
2. Import Fill should meet the requirements presented in our report.
3. Aggregate base should meet Caltrans Class II specifications.
4. Keyway should begin at top of ditch.
5. Staging details are presented on Plates 10 and 11.
6. Over-excavate landside berms within footprint of proposed levee and replace with import fill. Back-cut into existing levee should be no steeper than 2H:1V.

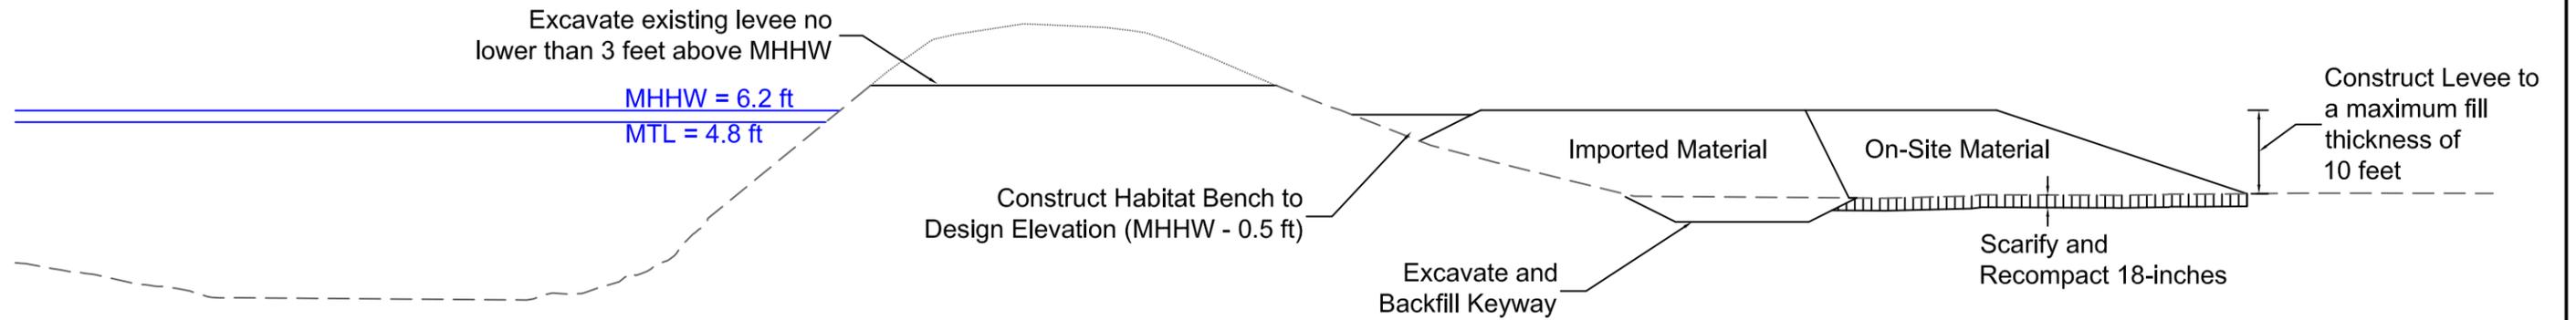
**STAGE 1**

**Stage 1 Notes:**

1. Excavate and backfill keyway per details shown on Plates 8 and 9. Keyway backfill should meet the specifications for Import Fill
2. Scarify and recompact 18-inches below planned levee.
3. Initial fill should be limited to 10 feet in thickness.
4. Habitat bench may be constructed between the existing and the setback levees.
5. The levee should not be degraded below Elevation 9.2 feet (3 feet above MHHW).
6. After initial 10 feet is placed, 1 month waiting period begins.

The design includes removing a portion of the existing levee. The construction work should be performed outside of flood season. The new setback levee needs to extend to sufficient height to provide flood protection prior to degrading the existing levee. We recommend that the new setback levee should be constructed to at least 3 feet above Mean Higher High Water along its entire length prior to degrading the existing levee. Additionally, we conclude that the existing levee should only be degraded if the contractor will be able to complete the setback levee prior to flood season. Typical staging details have been presented on Plates 10 and 11.

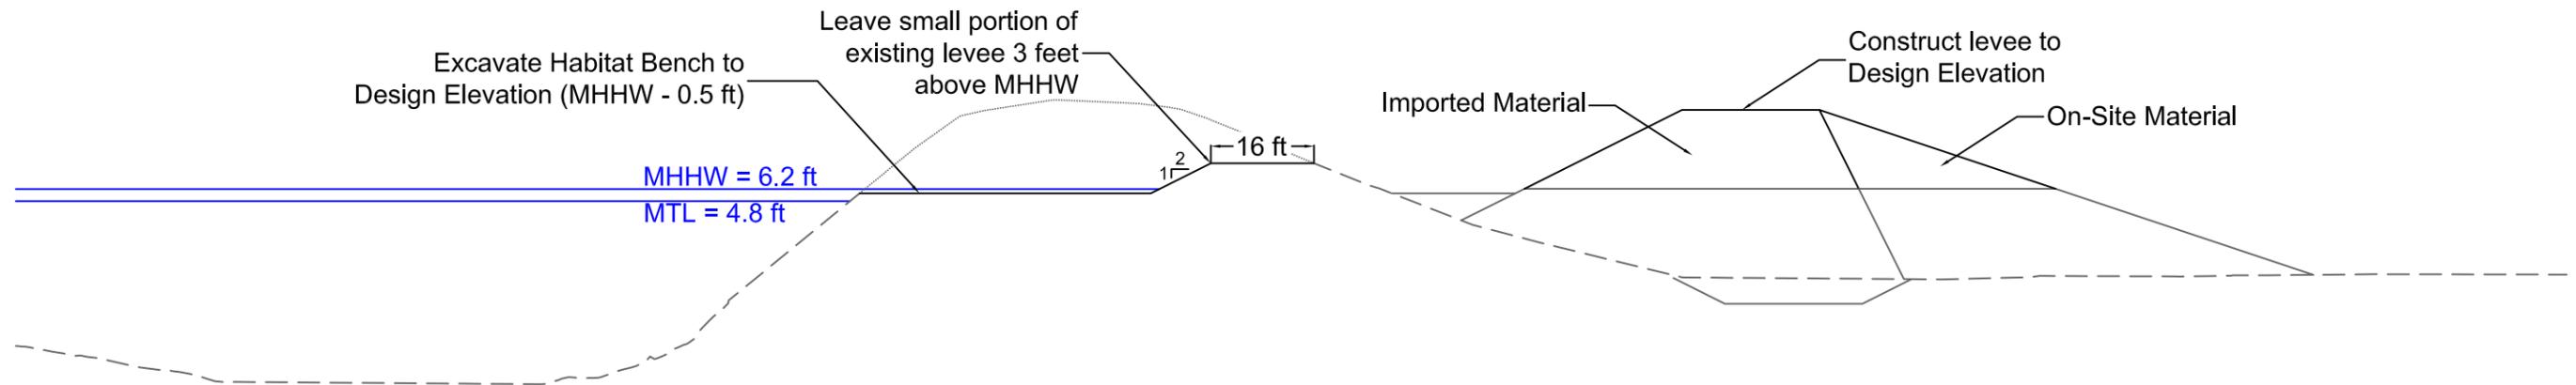
Plate No. 10

**Stage 2 Notes:**

1. After waiting period, the remaining portion of the setback levee may be constructed.
2. Once the new levee has been brought uniformly to 3 feet above MHHW (Elevation 9.2 feet), the existing levee may be degraded below Elevation 9.2 feet.
3. Excavate existing levee to Habitat Bench Design Elevation.
4. Leave a portion of the existing levee intact. The remaining levee should be at least 16 feet wide and a minimum of 3 feet above MHHW.

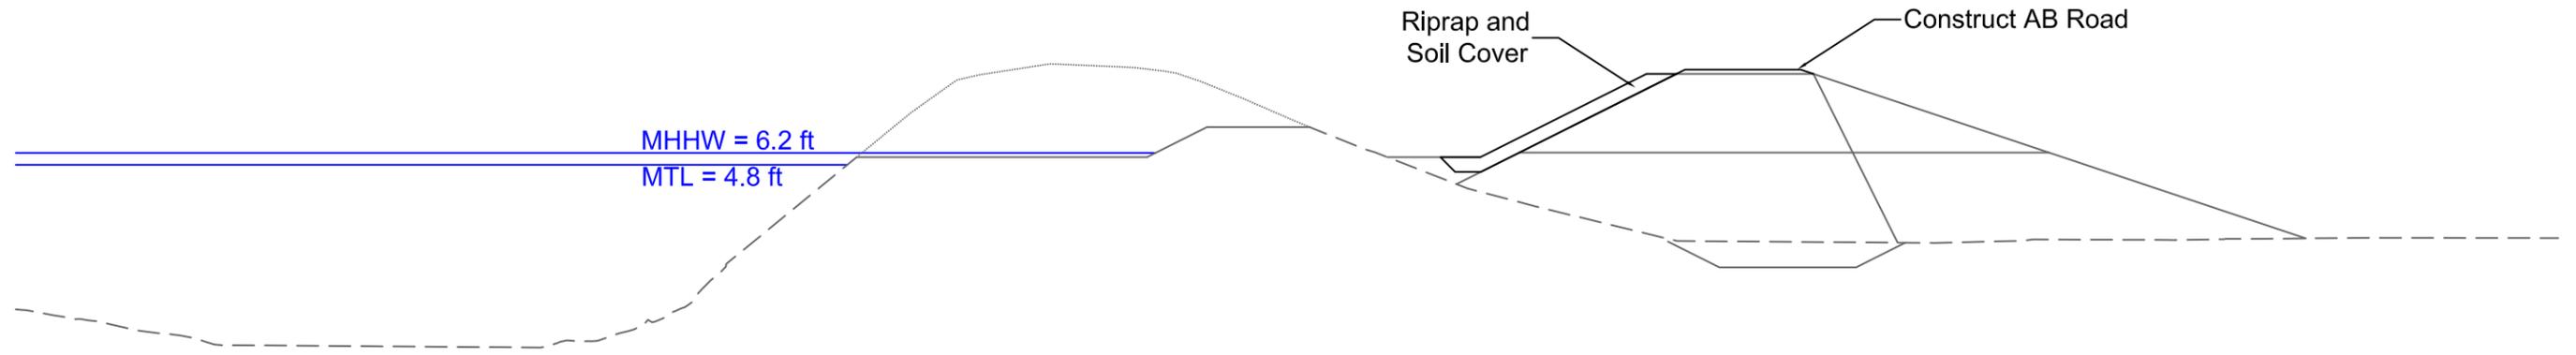
STAGE 3

Stage 3 Notes:

1. Construct waterside improvements, including riprap and soil cover.
2. After waterside improvements are completed, construct AB road on top of levee.

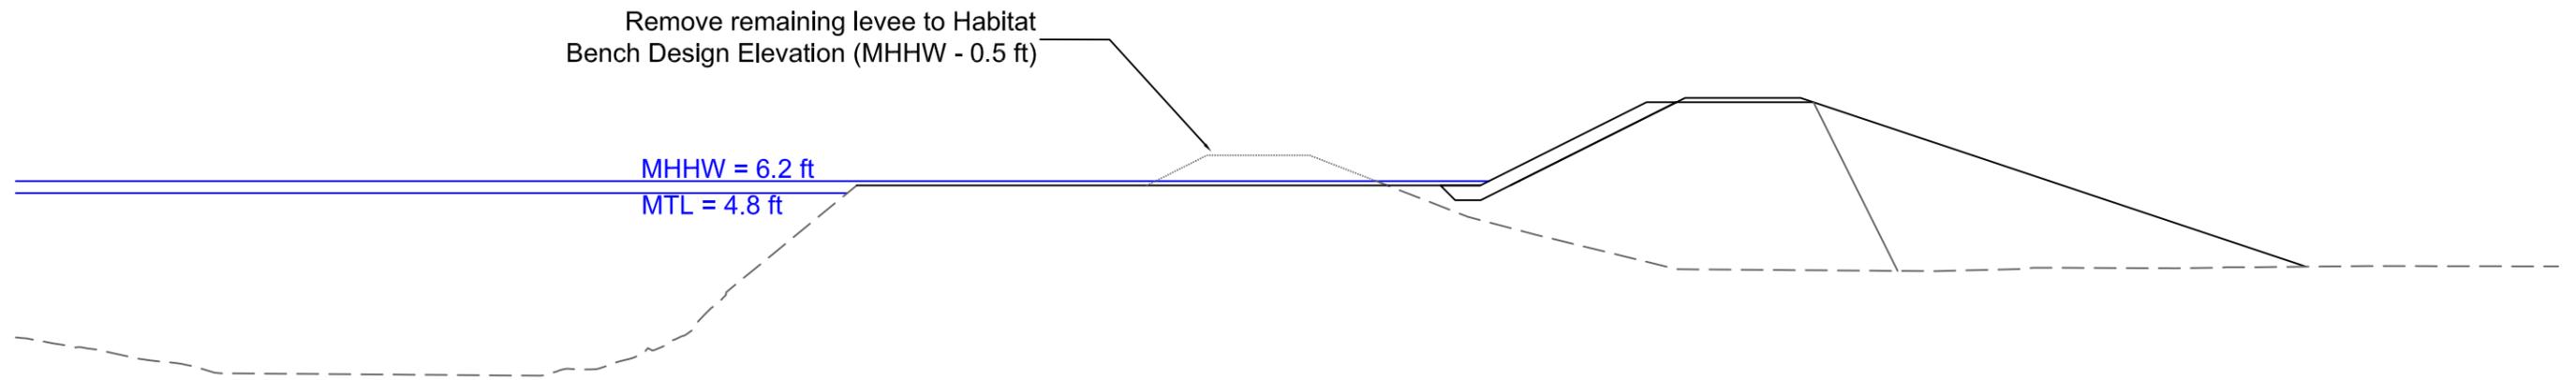
Stage 4 Notes:

1. Remove remaining levee portion to Habitat Bench Design Elevation.

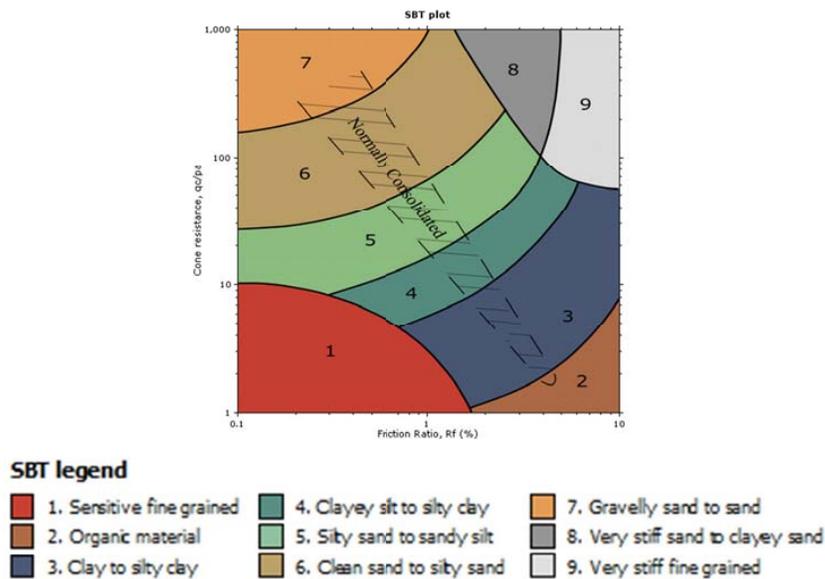
Figure SBT (After Robertson, 2010) – Note: Colors may vary slightly compared to plots

The Cone Penetration Test (CPT) data collected are presented in graphical and electronic form in the report. The plots include interpreted Soil Behavior Type (SBT) based on the charts described by Robertson (2009 & 2010). Typical plots display SBT based on the non-normalized charts of Robertson (2010). For CPT soundings deeper than 30m, we recommend the use of the normalized charts of Robertson (2009) which can be displayed as SBTn, upon request. The report can also include spreadsheet output of computer calculations of basic interpretation in terms of SBT and SBTn and various geotechnical parameters using current published correlations based on the comprehensive review by Lunne, Robertson and Powell (1997), as well as recent updates by Robertson and Cabal (Guide to Cone Penetration Testing, 2015). The interpretations are presented only as a guide for geotechnical use and should be carefully reviewed. Gregg Drilling does not warranty the correctness or the applicability of any of the geotechnical parameters interpreted by the software and does not assume any liability for use of the results in any design or review. The user should be fully aware of the techniques and limitations of any method used in the software. Some interpretation methods require input of the groundwater level to calculate vertical effective stress. An estimate of the in-situ groundwater level has been made based on field observations and/or CPT results, but should be verified by the user.

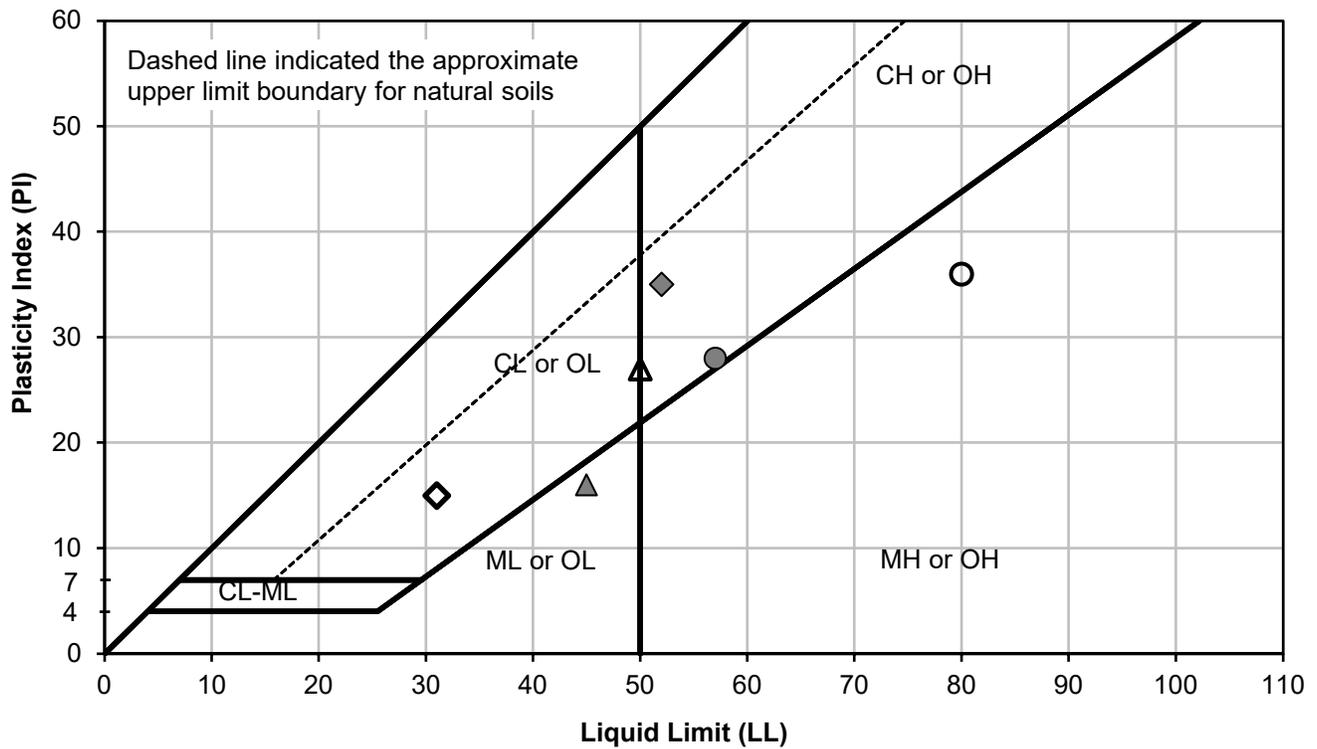
Plate No. C-1

Symbol	Boring Number	Depth (feet)	Soil Description	LL (%)	PL (%)	PI (%)	Moisture Content (%)
●	2	31-31.5	Blue Gray Fat Clay	57	29	28	37
▲	3	15.4-15.9	Brown with Dark Gray Silt	45	29	16	12
■	5	15.7-16.2	Light Reddish Brown Silty Sand	NP	NP	NP	16
◆	6	10.5-11	Gray Fat Clay	52	17	35	21
○	6	15.5-16	Brown Silty Sand	80	44	36	22
△	7	10.5-11	Bluish Gray and Olive Brown Fat Clay	50	23	27	28
□	7	40.5-41	Light Yellowish Brown Poorly-Graded Sand	NP	NP	NP	28
◇	9	10.5-11	Brown with Red Mottling Lean Clay with Sand	31	16	15	20

are presented in Appendix C. Atterberg limits test results are shown on Plates C-1 through C-6. Sieve analysis test results are shown on Plates C-7 through C-15. TxCU shear strength test results are shown on Plates C-16 and C-17. Consolidation test results are shown on Plates C-18 and C-19. The moisture content and dry density, and minus No. 200 content are presented on the individual boring and hand auger logs.

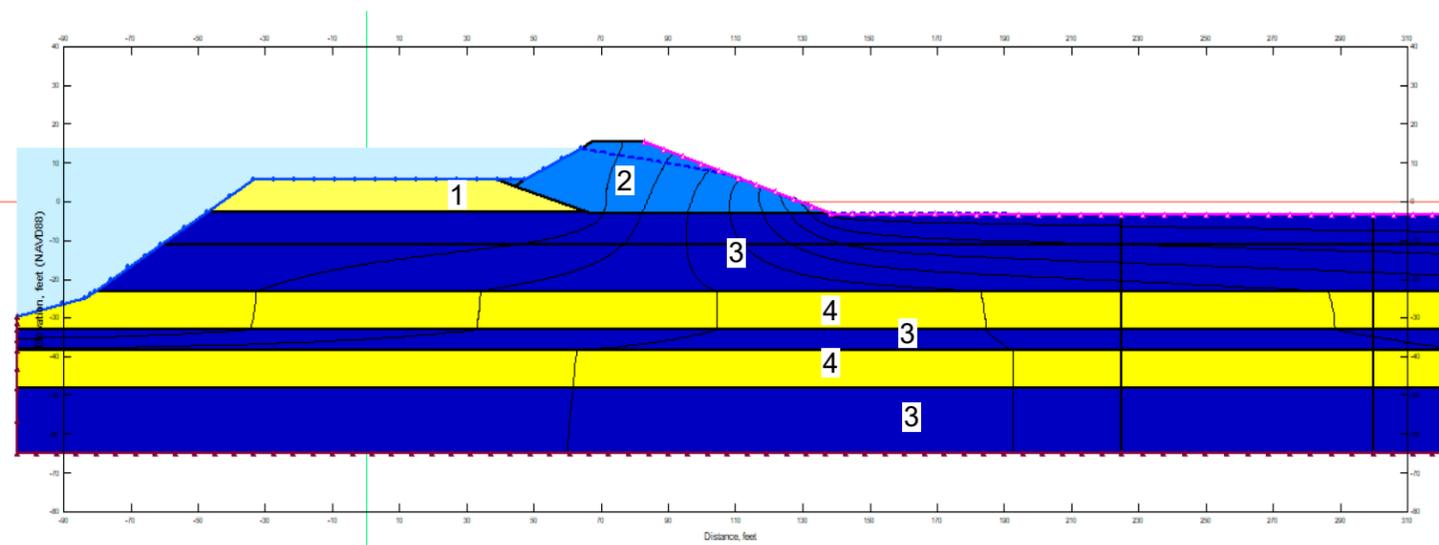
SEEP/W MODEL

TOTAL HEAD CONTOURS

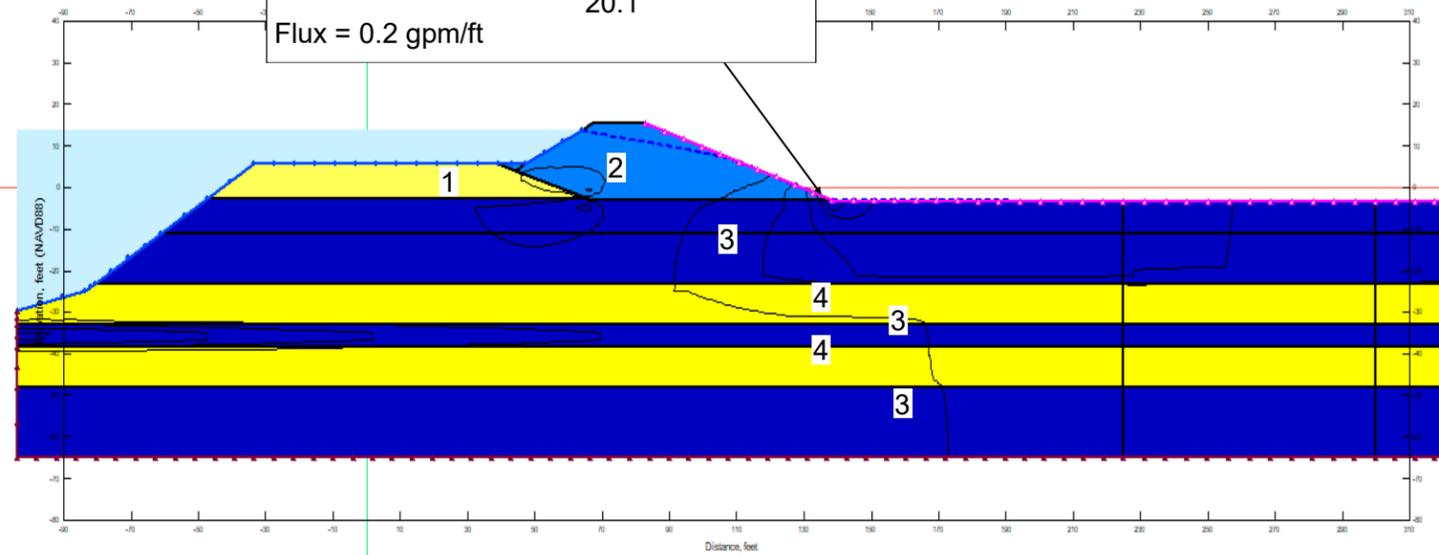
Local and Max Y-Gradient = -1.07  
 Local and Max XY-Gradient = 1.20  
 Average Y-Gradient =  $\frac{7.06 - (-3.01)}{20.1} = 0.50$   
 Flux = 0.2 gpm/ft

VERTICAL GRADIENT CONTOURS

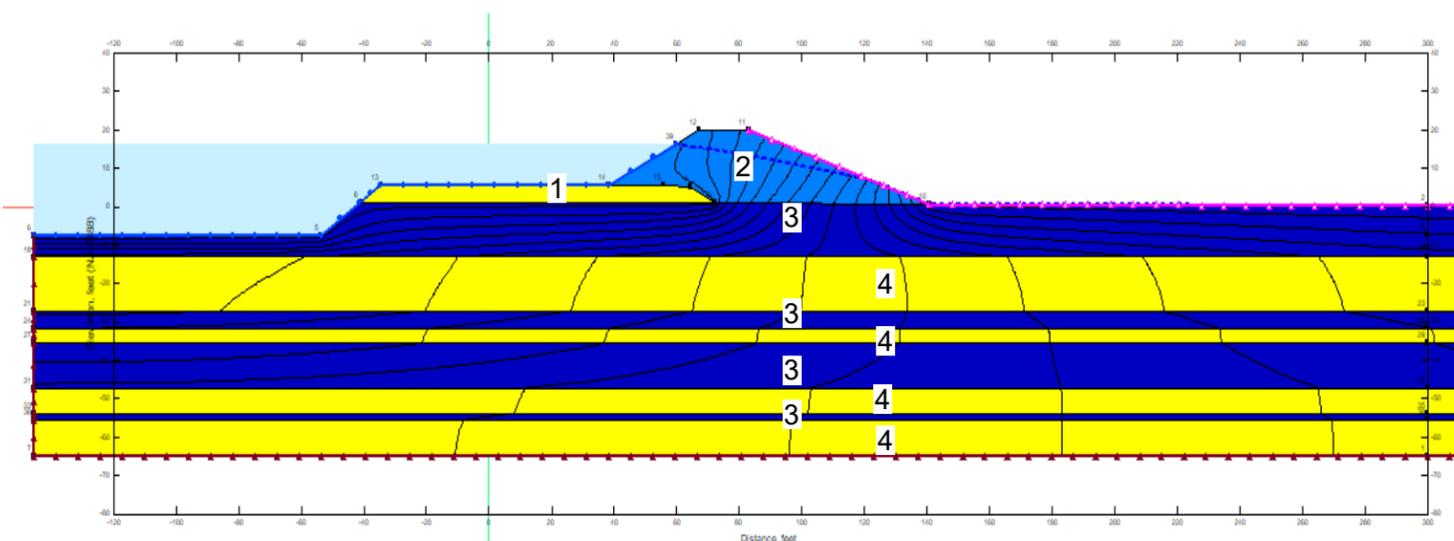
SEEP/W MODEL

TOTAL HEAD CONTOURS

SEEPAGE MODEL MATERIAL PROPERTIES				
UNIT NO.	LAYER COLOR	MATERIAL TYPE	VERTICAL CONDUCTIVITY, $k_v$ (cm/s)	PERMEABILITY RATIO, $k_H/k_V$
1	Yellow	Existing Levee Fill	$2.0 \times 10^{-3}$	9
2	Blue	New Levee Fill	$2.5 \times 10^{-6}$	4
3	Yellow	Sand	$1.0 \times 10^{-4}$	9
4	Blue	Clay	$5 \times 10^{-6}$	4
